**MOTOTRBO® 2.X System Release Notes**  
**Professional Commercial Radios (PCR) & Accessories**

Version: R02.50.05v01

**System Release R02.50.05 (R2.5.2)**

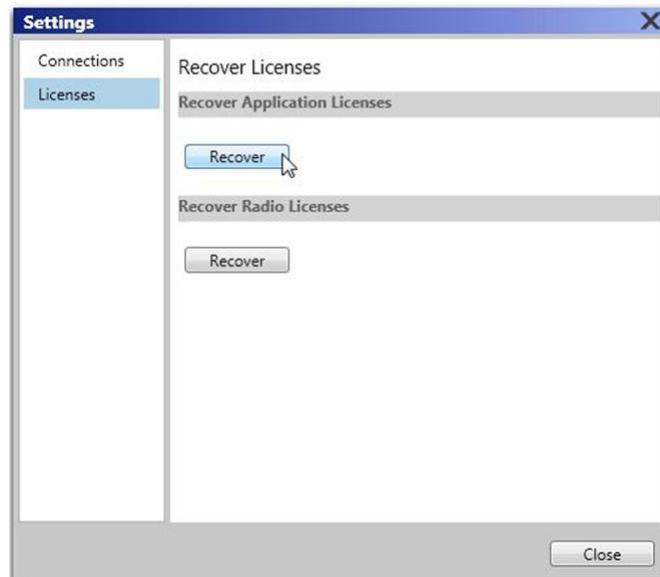
2. Click on the Licenses tab and click on Recover Application Licenses

After upgrading the RM Server to R1.2 the existing RM licenses need to be recovered as follows:
